Bank Barns

By Gary DiGiuseppe

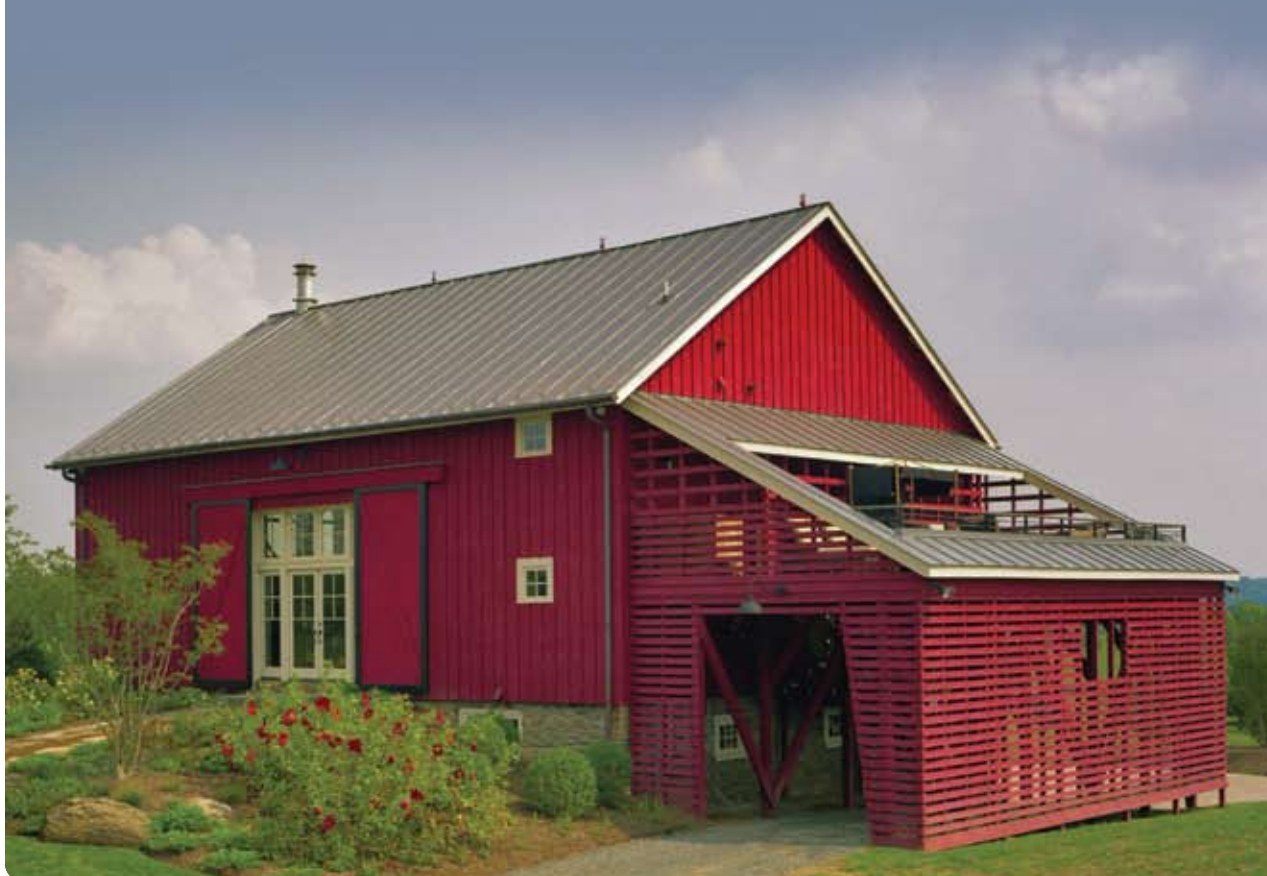
A “bank barn” is so named because it is built into an embankment—the side of a hill. Animals were housed on the lower floor, and grain and feed was stored in the top layer. According to the U.S. National Park Service, “The hillside entrance gave easy access to wagons bearing wheat or hay. (Fodder could also be dropped through openings in the floor to the stabling floor below.)” The long side of the barn was built parallel to the hill and on the south side of it, to provide the animals more sun in the winter. But in some cases, the Park Service notes, there was no hill at all: “A ‘bank’ was often created by building up an earthen ramp to the second level.”

Frequently, the structures had extended or cantilevered upper floors; this provided additional protection from the elements to the livestock. The overhang sometimes had to be propped up with additional columns or posts. The Park Service says in the earliest examples of bank barns, the narrow-end side walls are often stone or brick, with ventilation openings to ensure heat produced by the curing hay would not start a fire.

The overshoot on the upper level is called a forebay, according to Sally McMurry, professor of history at Penn State University; it usually projects 6-8’ over the front side of the barn, extending out over the doors that lead to the barnyard. She says there were big doors on the upper level that “lead to a threshing floor, haymow, and sometimes there’s a granary in there also.”

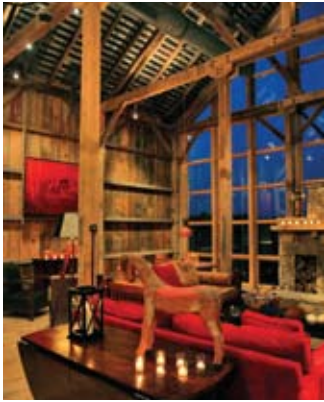
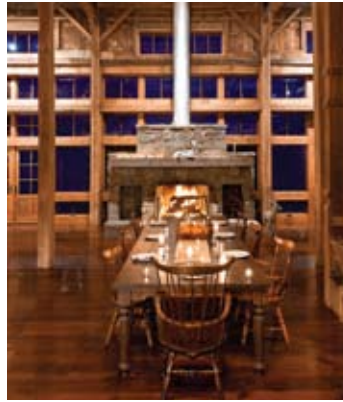
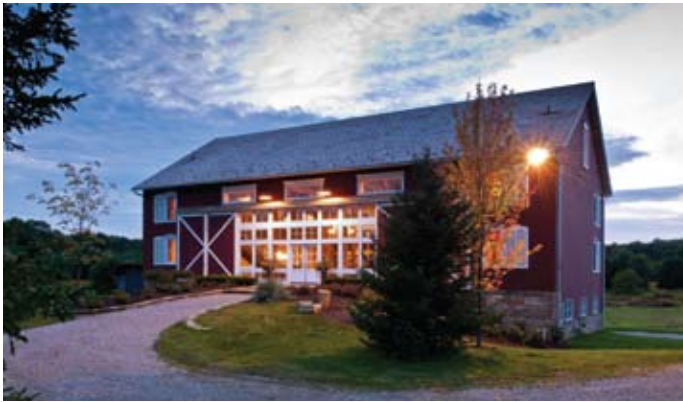
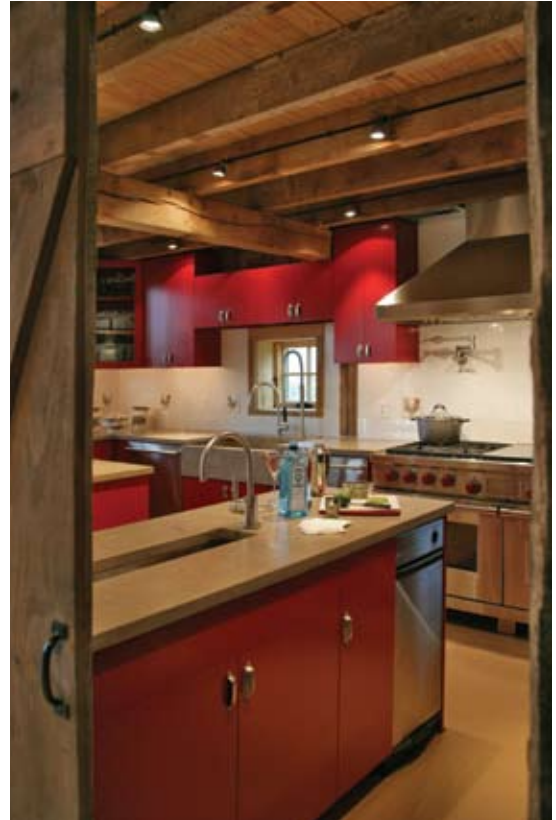
How do you do that? For one thing, it’s how you detail the barn. Because most barns are built with timber frames and board siding, they don’t offer the enclosure and protection needed for heating and air conditioning. At Blackburn’s web site, www.blackburnarch.com, he features pictures of a project called the New River Barn that won the 2006 Southern Living award. “A lot of people like old barns because they like the timber frames—the old patina, the old wood inside—and they want to keep that,” he explains. “So I wrap this barn in what’s called SIPs, Structurally Insulated Panels.” The panels are 4”-8” thick; after painting the faces and roof of the barn black and covering them with the SIPs, he in turn covered those with boards that matched the original siding.

“It’s about 6” further out than the original face,” Blackburn says, “but then when you go inside you have the original flooring and the original framework. The ceiling has the old slat boards on which the roofing was nailed down and the old, metal roofing, but on top of that is the SIPs, and on top of that is the new, metal roofing.” When you’re inside the barn, you see the original barn; when you’re outside, you see a façade that mimics the way the original barn looked.

To all of this, Blackburn added additional amenities. He rebuilt the corn crib and added a sun deck; he also replaced the north wall facing with glass. Since the owner also owns all the land for a half-mile (as we said, this can get expensive), privacy was not a concern.

Even with the SIPs enclosure, heating and cooling can be tricky because the buildings are so big. The New River Barn has a heated floor, and the duct work at ceiling level draws in the hot air as it rises and re-releases it lower in the structure. Blackburn says, “A lot of people will come in between the purlins—the framework on the inside—and put up insulation. That is the wrong thing to do, because it just destroys the look and it doesn’t give you thickness of the insulation that you need.”
